All-Pro Services, Inc Home Inspection Report

2707 BEAUTIFUL HOUSE ROAD, HERNDON, VA

Inspection Date: 07/01/2011

Inspector: Gregory Patti A.S.H.I. Certified Member #104266 Virginia Certified Home Inspector Va. Cert Number. 3380-000173 Radon Measurement Specialist NRSB # SS927

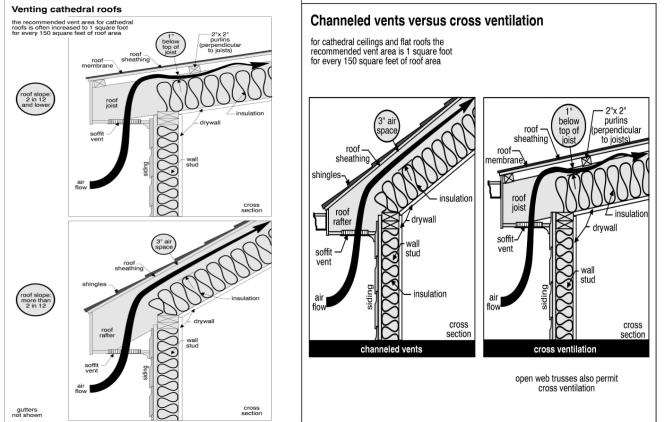
- **Improve:** The level of ventilation should be improved. It is generally recommended that one (1) square foot of free vent area be provided for every one-hundred and fifty (150) square feet of ceiling area. **Attic fans are an effective upgrade.**
- **Monitor:** The ventilation of the sloped ceiling over the garage is questionable. Proper ventilation of cathedral roofs is rarely achieved. As a result, these areas tend to be prone to difficulty, particularly in cold climates. Ice damming on the roof and condensation within the roof space are common problems. These areas should be monitored.

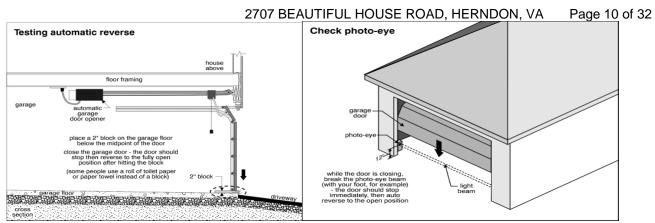
• **Repair, Safety Issue:** The overhead garage door is damaged and needs repair. The garage door opener did <u>not</u> automatically reverse under resistance to closing. *There is a serious risk of injury, particularly to children, under this condition.* This should be dealt with immediately. The opener may need replacement.

Improvement may be as simple as adjusting the sensitivity control on the opener. If only equipped with a photocell sensor, consider making sure that the sensor is at bumper height to help avoid damage.

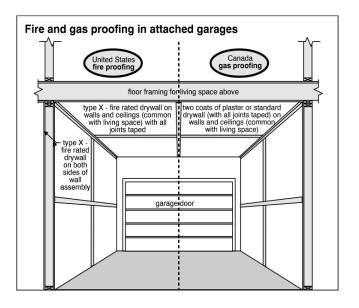
• Safety Issue: Repair: Proper fire separation between the garage and house is recommended. The walls and ceilings of the attached garages should be well sealed where they abut the interior of a house. This reduces the potential of fire and/or toxic automobile gases entering the house. Openings should be sealed for your protection. See the stairway and overhead storage area.

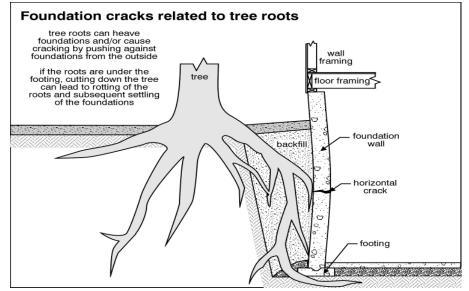
• **Monitor:** The proximity of a tree relative to the foundation or other structure may influence the integrity of the foundation, disrupt drainage pipes, or cause mechanical damage to the exterior of the house. Generally, root spread is comparable to branch spread. Monitor the situation and consider removal of the tree.

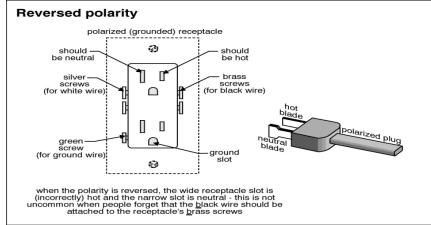
- **Repair:** A prong has broken off in an outlet in bedroom 3. Because of the broken prong, this outlet could not be tested.
- **Repair:** An outlet has reversed polarity (i.e. it is wired backwards) in the living room. This outlet and the circuit should be investigated and repaired as necessary.
